# INSPECTOR GENERAL

SEPTEMBER 30, 2013

## DoD Is Not Properly Monitoring the Initiation of Maintenance for Facilities at Kandahar Airfield, Afghanistan

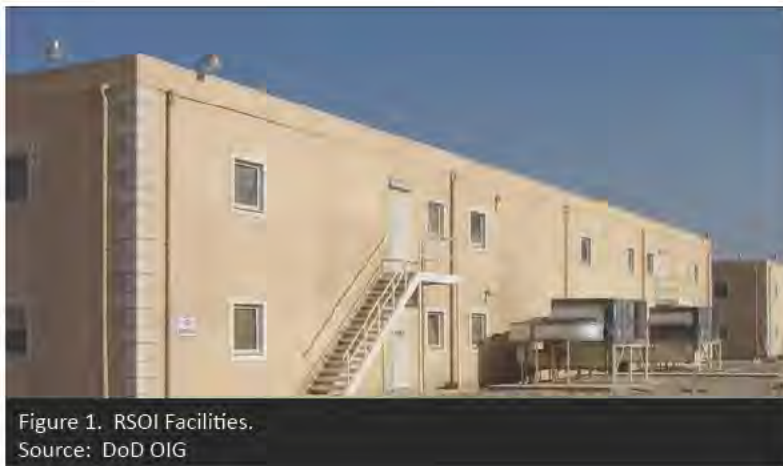
Figure 1. RSOI Facilities.  
Source: DoD OIG

~~(FOUO)~~ In 2012, the RSOI facilities, which cost about \$12.1 million to construct, required repairs that cost an estimated \$5.6 million, or 46 percent of the construction cost, before they could be added to the Density List. The RSOI facilities (see Figure 1) had construction deficiencies that required repairs from the LOGCAP contractor and a TF POWER contractor before they could be added to the Density List. Additionally, the fire suppression system and fire detection system did not meet fire code requirements, and both were inoperable, as of January 7, 2013. Although LOGCAP contractor personnel added the RSOI facilities to the Density List in 2012, they did not accept the fire suppression system and fire detection system.

The RSOI facilities required an estimated \$5.6 million in repairs before they could be added to the Density List: \$3.2 million for repairs performed by the LOGCAP contractor and \$2.4 million in electrical repairs performed by a TF POWER contractor. When U.S. military personnel initially occupied the RSOI facilities in 2009, the facilities were not added to the Density List. During the year the facilities were occupied, they deteriorated significantly. The personnel were later evacuated due to electrical deficiencies that posed a safety threat (U.S. military personnel occupied the RSOI facilities off and on from 2009 to 2012).

In addition, in June 2012, TF POWER reviewed the entire facility's electrical system and found the external feeder cables, interior wiring, electrical panels, raceways, and electrical devices consisted of nonlisted materials. The electrical system, from the power house through the entire RSOI facilities, did not meet standards and was deemed unsafe. Therefore, on July 30, 2012, TF POWER used the USACE-Philadelphia District to contract the electrical repairs to Inglett & Stubbs International, which cost \$2.4 million, according to the Deputy Director, TF POWER.

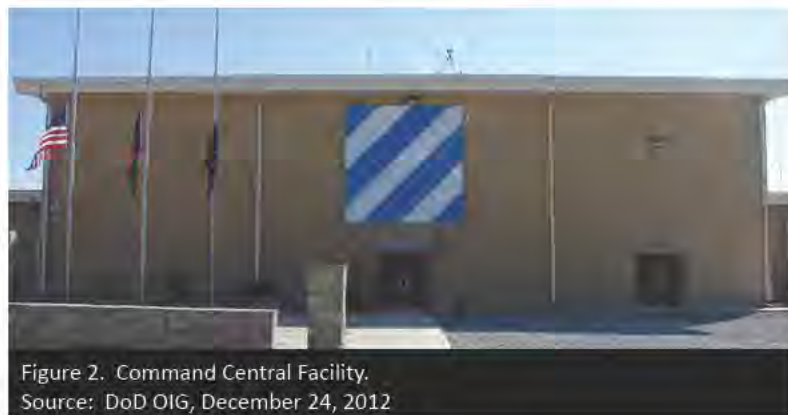
On October 31, 2011, the Command Central facility was added to the Density List without the required repairs; however, the facility would receive repairs later in 2012. The facility was not occupied until the 3<sup>rd</sup> Infantry Division deployed to KAF in July 2012 (see Figure 2). After the facility was occupied, tenants experienced chronic HVAC system deficiencies due to poor quality construction by the USACE-TAD construction contractor.

During the summer of 2012, the HVAC system was not cooling sections of the facility. Command Central officials stated that the facility was usually 100 to 120 degrees inside during the summer, and the temperature of the commanding general's office was higher than the outside temperature.<sup>9</sup> Therefore, on July 10, 2012, the tenants contacted the LOGCAP contractor to repair the Command Central facility's HVAC system, but contractor personnel provided only a temporary repair.

On July 26, 2012, USACE-TAD assessed the HVAC system and identified that the compressors were unworkable; USACE-TAD contacted the construction contractor to make the necessary repairs under warranty. The USACE-TAD construction contractor did not repair the HVAC units. On October 17, 2012, the USACE-TAD contracting officer signed a memorandum stating:

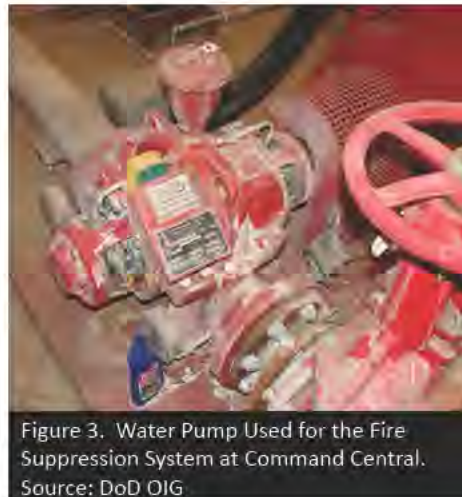
Figure 3. Water Pump Used for the Fire Suppression System at Command Central.  
Source: DoD OIG

~~(FOUO)~~ The fire detection system and the fire suppression system in the Command Central facility were not operational. On October 28, 2011, the LOGCAP contractor performed a technical inspection on the Command Central facility and identified several fire safety deficiencies. The LOGCAP contractor's technical inspection identified that there were no test records of the fire detection system and that it did not appear to meet standards. Additionally, the LOGCAP contractor's inspector noted that he was unable to walk through the entire facility because USACE-TAD personnel rushed him through. Consequently, the LOGCAP contractor rejected the fire protection system from inclusion on the Density List, even though the facility was added to the Density List on October 31, 2011.

~~(FOUO)~~ On June 27, 2012, the LOGCAP contractor fire inspectors reviewed the Command Central facility and noted several fire deficiencies. The LOGCAP contractor's fire inspectors identified that the facility did not have enough smoke detectors, and if the fire alarm goes off, the security system will lock the doors and impede exit and entry into the facility. After the inspection, the LOGCAP contractor installed single station battery-operated smoke detectors in the facility.

~~(FOUO)~~ On a December 23, 2012, visit to the Command Central facility to verify the problems reported by the LOGCAP contractor, a DCMA fire subject matter expert found that the fire detection system and fire suppression system were not operational. Figure 3 shows the poor condition of the water pump used for the fire suppression system at the Command Central facility. Specifically, when the fire alarm was pulled, nothing happened. In addition, the interior doors appeared to have had their locking mechanisms removed, which would prevent the doors from locking unexpectedly upon alarm activation. The tenants did not know that the fire detection system and fire suppression system did not work; therefore, the DCMA official instructed the facility managers to change their standing operating procedures and notify the occupants.

~~(FOUO)~~ On January 16, 2013, the Director, TF POWER, stated that TF POWER planned to repair the fire suppression system and the fire detection system at the Command Central facility. USFOR-A should expedite repairs to the fire suppression system and the fire detection system at the Command Central facility. Additionally, USACE-TAD should review the actions of the official(s) that conducted contract oversight and approved the inoperative fire suppression system and fire detection system at the Command Central facility; and, as appropriate, initiate corrective measures and actions to hold personnel accountable.

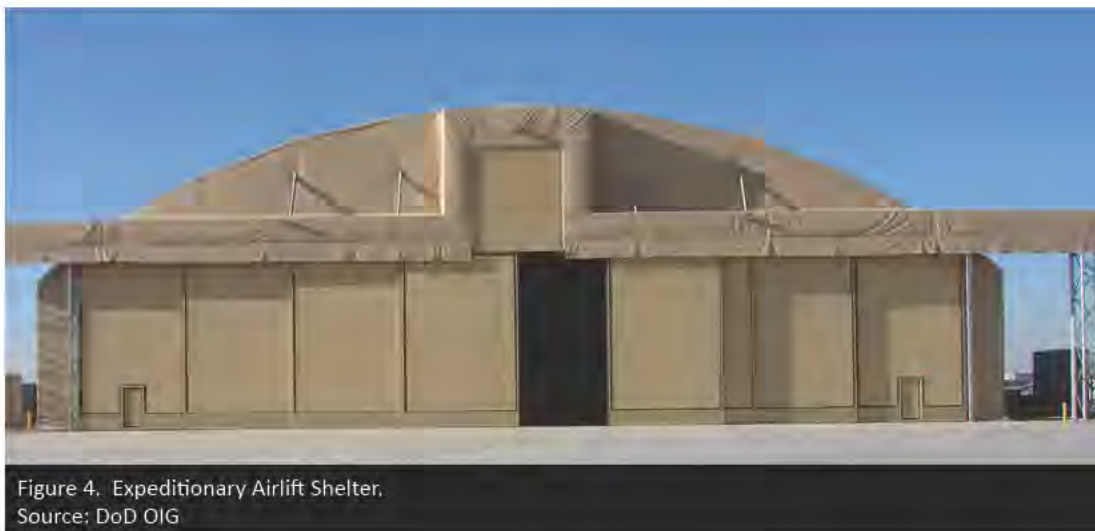
Figure 4. Expeditionary Airlift Shelter.  
Source: DoD OIG

The LOGCAP contractor rejected the Expeditionary Airlift Shelter (see Figure 4) from inclusion on the Density List because they identified construction deficiencies in the electrical and HVAC system. The LOGCAP contractor performed two technical inspections on the Expeditionary Airlift Shelter in August and October 2012, which identified electrical deficiencies, such as an unapproved conduit method for primary and secondary transformers, improperly protected grounding electrode conductors, and two grounds terminated under a lug designed for one. HVAC deficiencies included two large units that were not operational, an absent fire damper, and the wall penetration was not rodent proofed. The LOGCAP contractor requested correction to these construction deficiencies before adding the Expeditionary Airlift Shelter to the Density List. As of March 22, 2013, the Air Force was not using the Expeditionary Airlift Shelter because it would not accept the facility until it was added to the Density List.

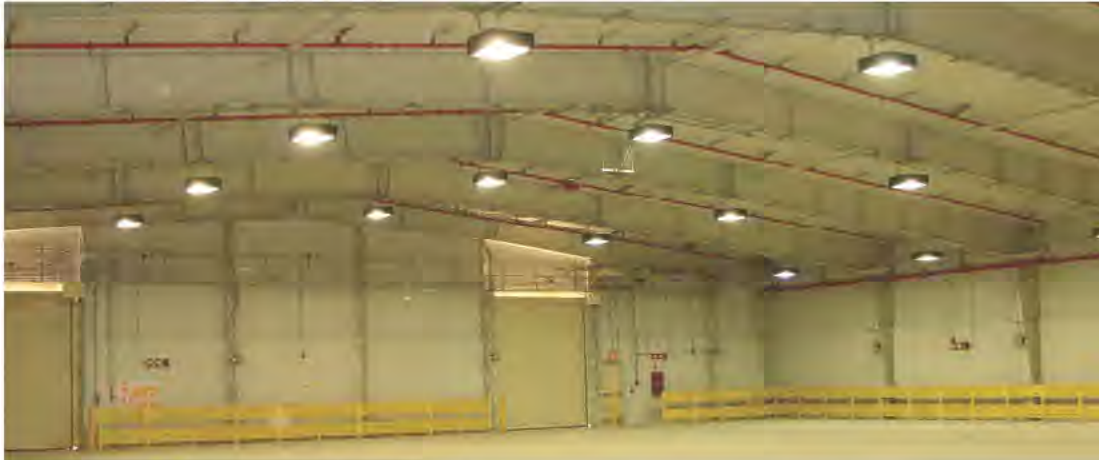
Figure 5. Inside the Cargo Handling Warehouse.  
Source: DoD OIG

LOGCAP contractor personnel also rejected the Cargo Handling Warehouse from inclusion on the Density List because they identified construction deficiencies with its electrical and HVAC systems. The LOGCAP contractor performed two technical inspections in September and November 2012 and identified that electrical panels did not have proper working clearances, individual conductors were too small for the cable trays, and the conductors in the cable tray inside the fire pump house needed to be derated. In addition, the LOGCAP contractor identified that the HVAC unit was inoperable and had safety hazards. The LOGCAP contractor requested correction to these construction deficiencies before adding the Cargo Handling Warehouse to the Density List. On January 4, 2013, we conducted a walkthrough of the vacant warehouse before the

facility was accepted by the Air Force (see Figure 5). On February 4, 2013, the Air Force partially accepted the Cargo Handling Warehouse from USACE-TAD because of mission needs. The Air Force uses the warehouse only for temporary storage, according to a 451<sup>st</sup> ECES official. However, on March 22, 2013, we visited the warehouse and it was empty.

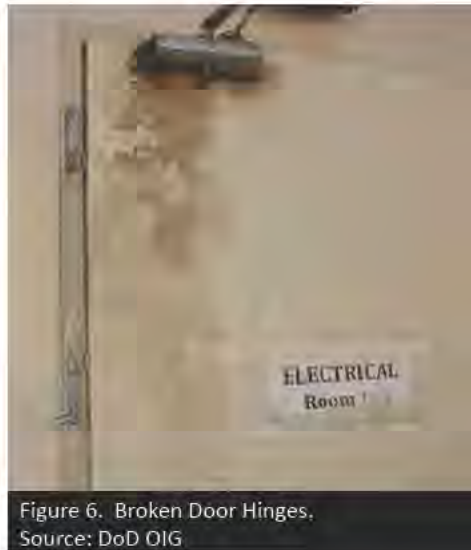
For example, on December 24, 2012, one facility had two doors that were off their hinges. The USACE-TAD construction contractor previously repaired the two doors, but they required additional repairs. In an undated performance evaluation of the construction contractor at 98 percent completion, the USACE resident engineer wrote that the contractor did not immediately correct deficient work after it was identified by USACE personnel.

Later on January 4, 2013, a 451<sup>st</sup> ECES official stated that facilities were not up to the LOGCAP contractor's standards for placement on the Density List. The doors of one facility we visited were off their hinges (see Figure 6) and its latrines did not work because of a broken water line. On a subsequent walkthrough on January 25, 2013, we identified two other facilities with several doors that had broken hinges. When we performed the walkthroughs, the facilities were about a year old, according to a 451<sup>st</sup> ECES official.

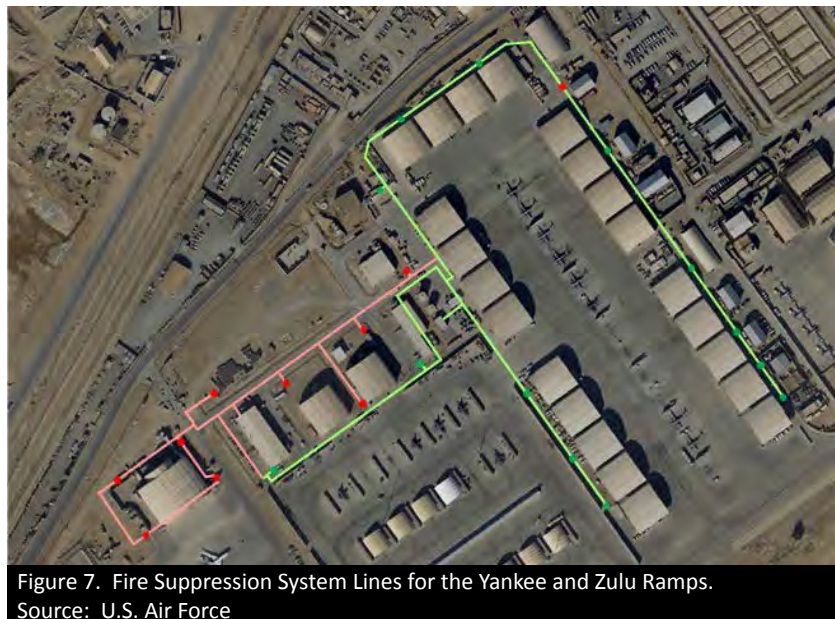
~~(FOUO)~~ The fire suppression system for Yankee and Zulu Ramps facilities was inoperable. On May 9, 2012, USACE-TAD accepted the water pump station for the fire suppression system (valued at \$417,458) from the construction contractor. However, on July 7, 2012, the LOGCAP contractor performed a second technical inspection and noted that the facilities on the Yankee and Zulu Ramps did not have any of the previously identified construction deficiencies corrected.<sup>11</sup> LOGCAP contractor personnel noted that they did not recommend conducting any flow testing or system testing until the entire system was evaluated and repaired, from the pump house to the hangars, isolating one portion of the infrastructure at a time. Furthermore, the LOGCAP contractor stated that flow testing or system testing prior to an entire system evaluation could result in injuries to personnel; damages to the current infrastructure to the point it would have to be replaced rather

(FOUO) than repaired; or more uncommanded activations<sup>12</sup> that could damage aircraft or support equipment. The Air Force requested that the USACE-TAD construction contractor fix the fire suppression system. If the USACE-TAD construction contractor does not fix the fire suppression system, USFOR-A should expedite repairs to the fire suppression system at the Yankee and Zulu Ramp facilities.

(FOUO) According to a 451<sup>st</sup> ECES official, as of January 25, 2013, all fire hydrants and the fire suppression system were shut down in the Yankee and Zulu Ramps. Specifically, the diesel pump in the pump house was turned off due to fire alarm testing in five hangars; therefore, the fire department would have been unable to use the fire hydrants in the event of a fire, as they would not have had enough water pressure, according to the 451<sup>st</sup> ECES official. See Figure 7 for the Yankee and Zulu Ramps operational (green line) and nonoperational (red line) fire suppression system. The red water supply lines had been isolated and were not pressurized at Zulu Ramp. Therefore, five facilities at Zulu Ramp did not have fire suppression capabilities. Nine fire hydrants on Zulu Ramp and one fire hydrant on Yankee Ramp were also not operational. Unified Facilities Criteria 3-600-01, Section 6-16.2, states that the minimum separation between tension fabric hangars and all other structures will be 100 feet with a clear zone of 50 feet immediately adjacent to the tension fabric structure. Without an operational fire suppression system, there was an increased risk that a fire within one of the hangars could spread to multiple hangars because the Yankee Ramp facilities were located approximately 10 feet from one another. During the audit, the Air Force informed us that it was aware of these fire safety concerns, and have requested that the USACE-TAD construction contractor fix the fire suppression system.
